# **BATTLESHIP TEXAS (BB-35)**

## **VESSEL INSPECTION AND ASSESSMENT**

Vessel Survey Report No. 2417

Vessel surveyed at:	La Porte, Texas
Dates of survey:	November - December 2010 January 2011
Vessel surveyed:	Battleship TEXAS (BB-35)
Survey commissioned by:	Texas Parks & Wildlife Battleship TEXAS State Historic Site 3523 Independence Parkway South La Porte, Texas 77571
Purpose of survey:	Vessel Condition Survey

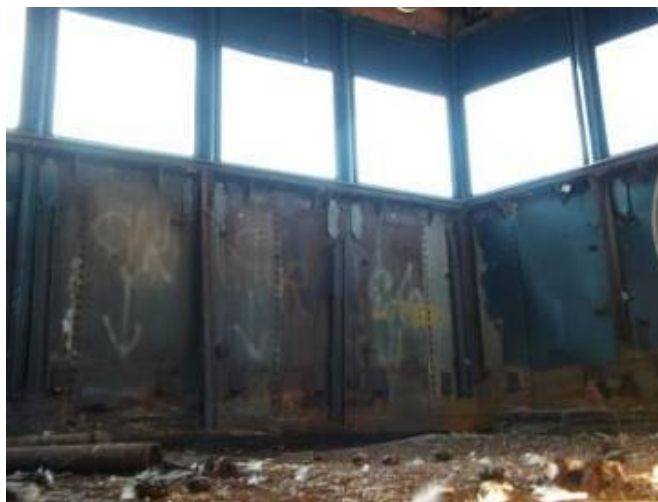
The exterior of this structure is in need of repair in that the support scantlings have water draining onto them from leaks within the Lookout Station (Figure 12 and Figure 13). There is a broken window in the structure allowing an owl to live there with the attendant debris field (Figure 14). The interior of the lookout station is badly scaled and is in need of restoration. The tripod legs appear to be in good repair with the usual rust/scale at the various platforms and support structure (Figure 15 and Figure 16); there is no sagging visible and the structure below decks appears to be in fine shape and well supported.

**Figure 14 Interior of Lookout Station Showing Rust/Scale and Collapsing Floor (This Space Has Seriously Deteriorated Since Inspection in 2006)**

**Repair wasted deck in lookout enclosure.**

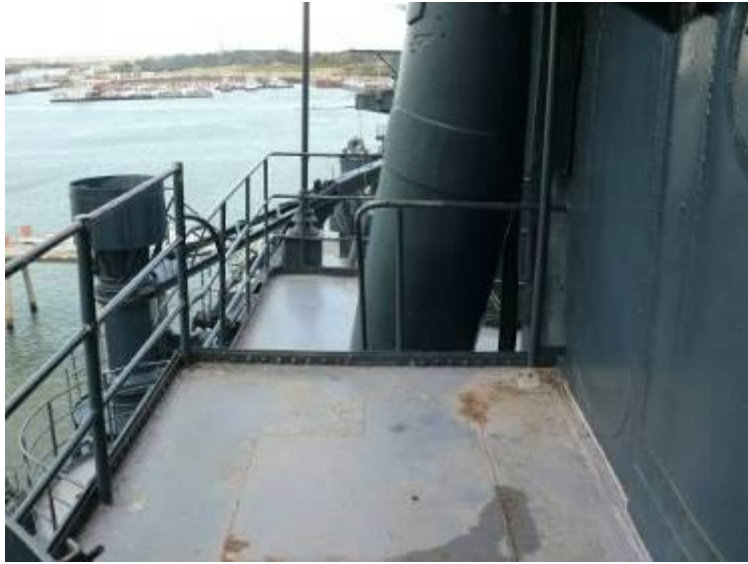
The deck on the Flag bridge is heavily wasted to starboard and aft on the public tour route (Figure 17, Figure 18 and Figure 19).

**Figure 17 Flag Bridge Looking Aft to Starboard**

**Prepare, prime and paint entire structure.**

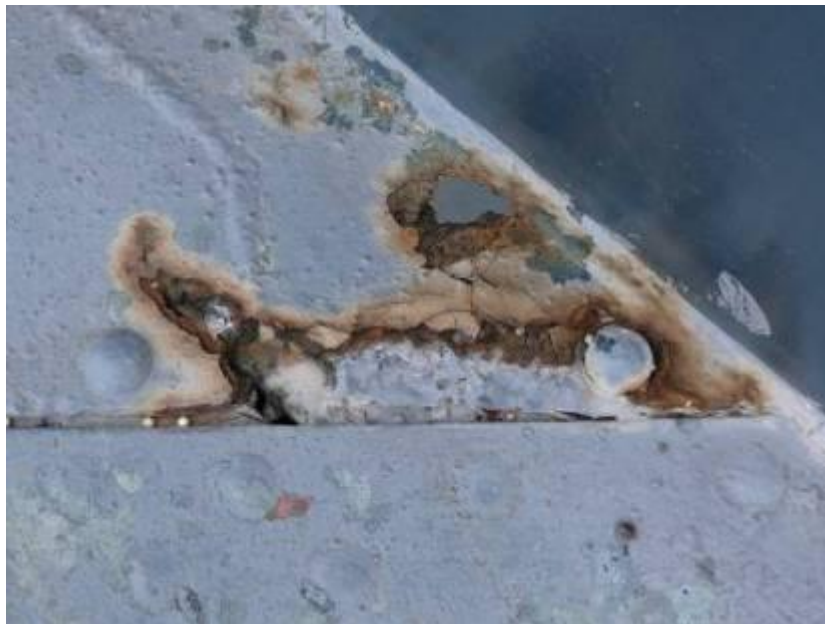
**Figure 18 Wasted Deck Plating at Riveted Seam on Public Access Route on Flag Bridge Level**

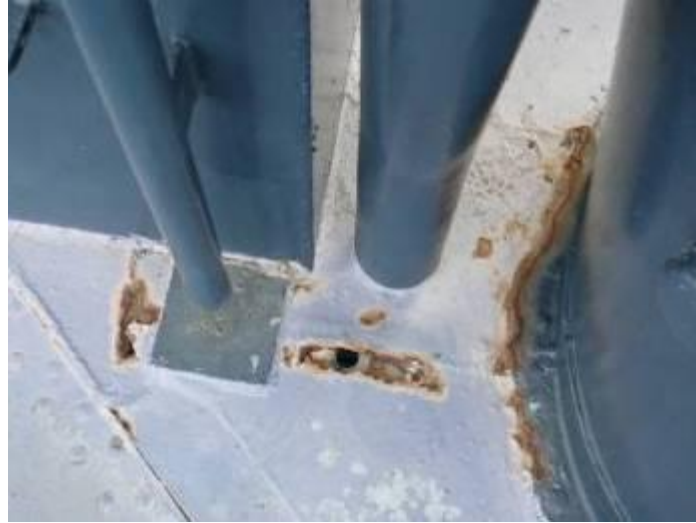
**Figure 19 Heavily Wasted Deck at Starboard Site Aft leg on Foremast Tripod at Flag Bridge Level**

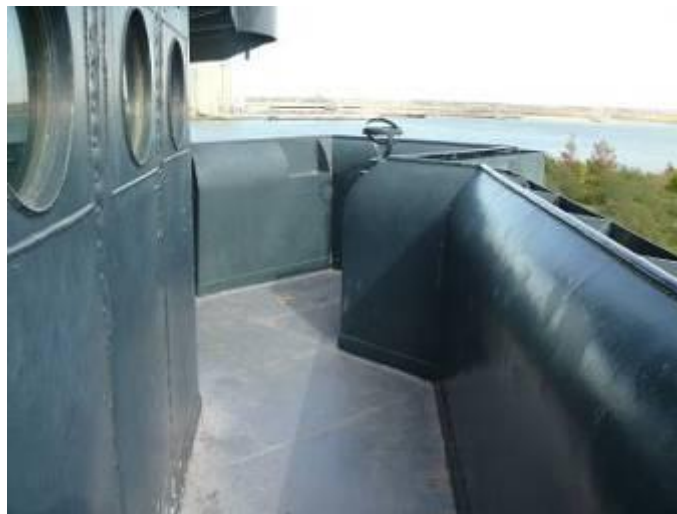
The deck plating and support structure on the Navigation Bridge are severely deteriorated (Figure 20 and Figure 21).

**Figure 20 Navigation Bridge Exterior (Looking Forward to Starboard)**

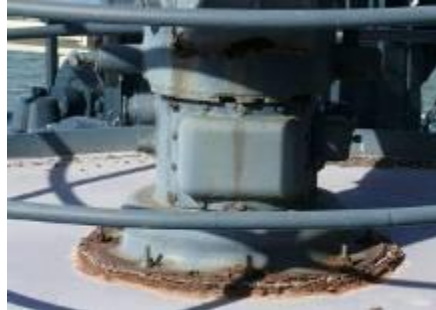
This space (Figure 22 and Figure 23) contains platforms and foundations for the pair of 36 in. searchlights. The bases of these lights are severely deteriorated. The area surrounding the searchlights and the lights themselves are suffering from rust/scale.

**Figure 22 Deteriorated Base of Starboard Searchlight**

**Repair wasted deck plating below searchlights and support structure as this is a public access area.**

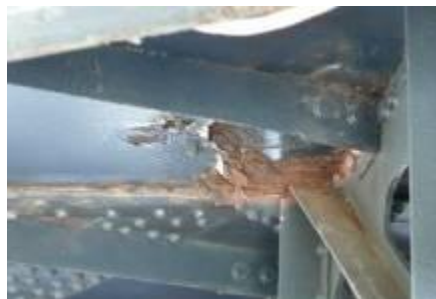
**Figure 23 Overhead of Searchlight Platform Showing Heavy Rust/Scale and Structural Failure**

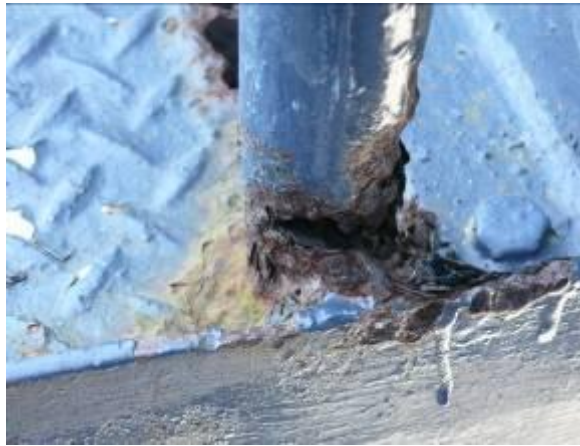
This raised platform contains the flag bags for the signal bridge and a single quad 40 MM mount outboard. There is rust/scale degradation to the space's railings that must be addressed as a safety issue being a public access space. The pair of quad 40MM mounts are suffering from heavy rust/scale (Figure 24, Figure 25 and Figure 26).

**Figure 24 Wasted Handrail on Stanchion Base**

**Repair handrail stanchions, renew stanchions and foundations throughout space.**

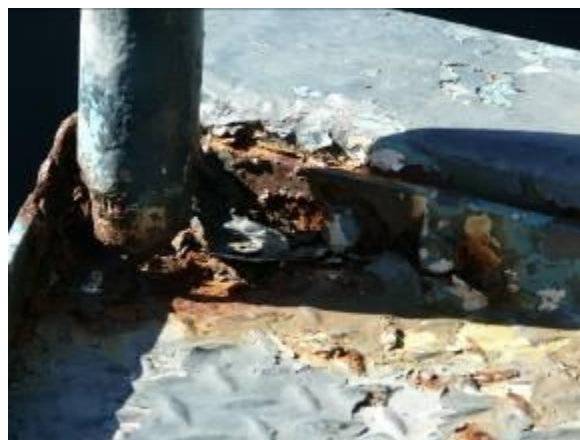
**Figure 25 Blocked Drainage and Wasted Stanchion Base on Signal Bridge**

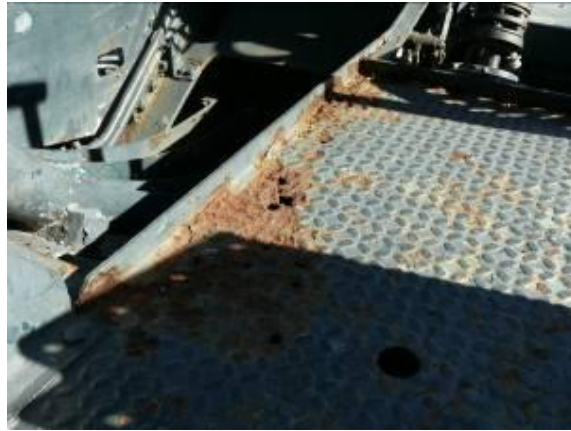
**Figure 26 Wasted Diamond Plating on 40MM Gun Mount to Starboard**

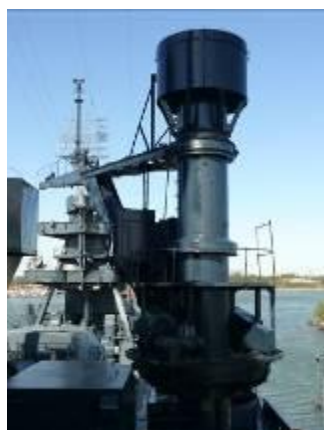
**Figure 27 Boat Crane (Port)**

The boom is present, but the rigging and sheaves have been down-rigged (Figure 27). The crane base is in excellent structural condition and the foundation is in good repair. Some degradation of tie rods and connecting bolts is apparent, but not critical at this time. 20MM guns have been removed from top of crane. The structure is in good cosmetic condition. There is minor standing water and blocked drainage with resultant wastage of deck plating and crane base structure.

**Clear crane drainage of dirt/debris.**

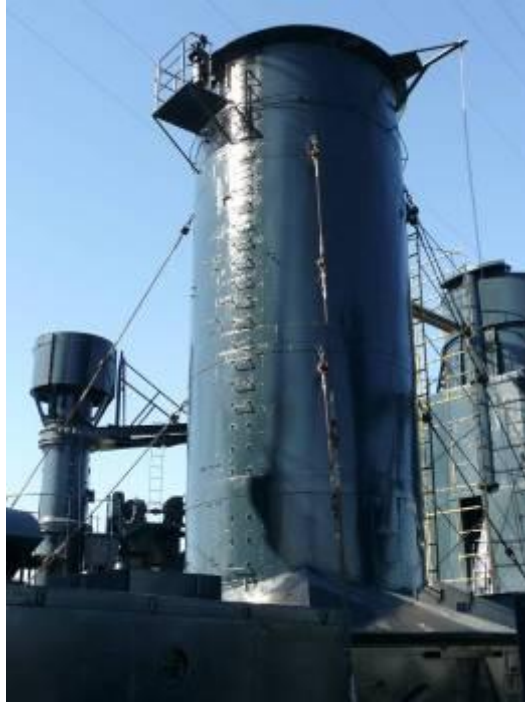
**Figure 29 Stack**

This structure (Figure 29) is in great cosmetic and good structural condition. Supporting standing shrouds, turnbuckles and mounting bases/foundations are in good material condition. Stack structure itself is in good repair with little degradation noted and is well painted.

**Inspect and repair as necessary all shackles, mousing wires and seizings for shrouds on a systematic basis.**

**Consider uniform tightening of shrouds to a snug condition.**

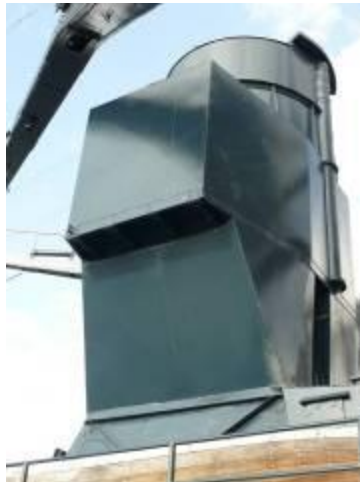
**Figure 30 Main and Secondary Battery Control Shell**

The outboard shell (Figure 30) is in good structural condition. Mounting bases/foundations on superstructure deck are in poor to fair material condition. External structure itself is in good repair with little degradation noted. The structure is in great cosmetic condition and is well painted. The internal structure main scantlings are in good repair, but heavy rust/scale is present on the upper and lower battery control decks with failed plating present.

**Upper and lower decks for battery control stations badly corroded and is a safety hazard; repair and replace decks in these two areas.**

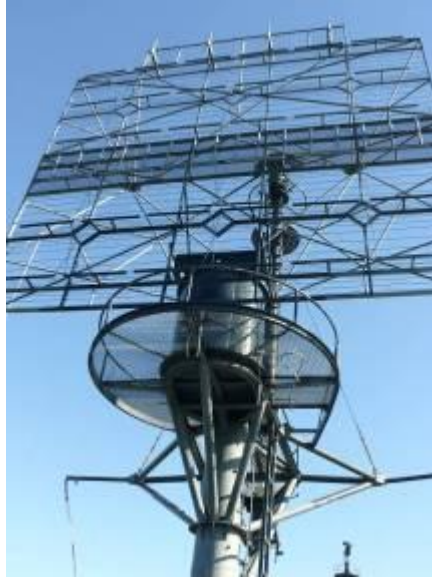
**Figure 33 Spar and Antenna Support Structure**

This highest appendage (Figure 33) is in excellent structural condition; the large radar array was

replaced at time of last dry-docking. The cosmetic coating is starting to fail.

<b>Prepare, prime and paint structure.</b>
--

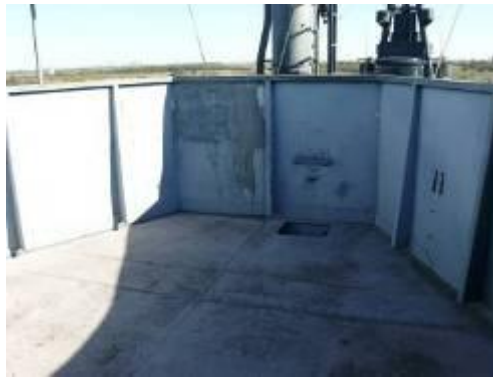
**Figure 34 Sky Control Aft Platform**

This structure (Figure 34) is in good structural condition with good drainage.

<b>Prepare, prime and paint interior bulkheads and deck as needed.</b>
--

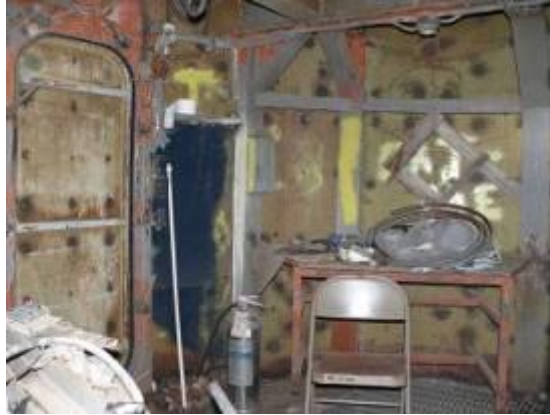
**Figure 35 20 MM Clipping Room**

This space (Figure 35) is in good structural condition with good drainage.

<b>Prepare, prime and paint interior bulkheads and deck as needed.</b>
--

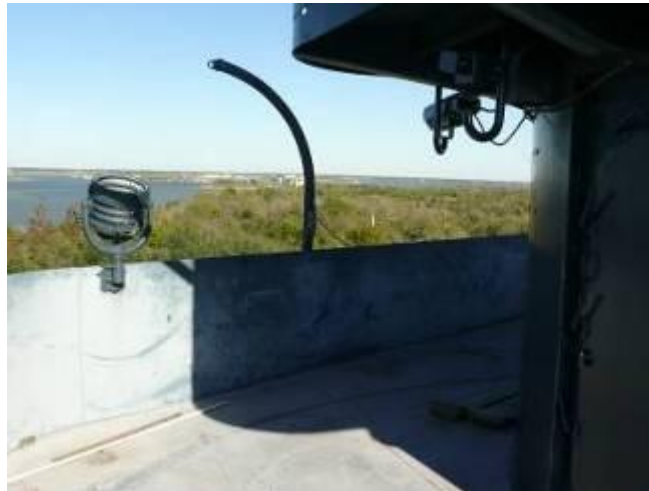
**Figure 36 20 MM Gun Platform**

This structure (Figure 36) is in good structural condition with good drainage.

<b>Prepare, prime and paint interior bulkheads and deck as needed.</b>
--

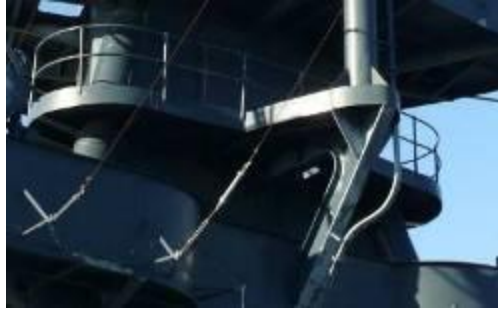
**Figure 37 Surface Lookout Platform**

This structure (Figure 37) is in good structural condition with good drainage.

**Prepare, prime and paint railings and deck as needed.**

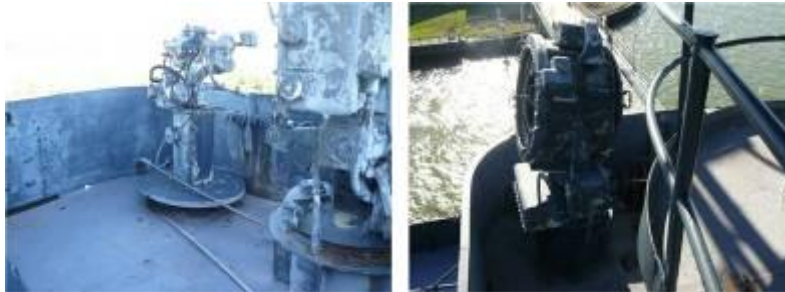
**Figure 38 Direct and Searchlight Platform**

This platform contains the pair of directors and two 36" searchlights (Figure 38 and Figure 39). Both pairs of directors and searchlights are in need of immediate repair/restoration as the effects of weather are rapidly deteriorating the base structural members and components of these units to a very sad state. Standing water is an issue with deteriorated deck and heavy rust/scale present. The pair of searchlights have name plates assigning them to ARIZONA (Figure 40) which make them certainly worthy of a complete restoration due to their significance.

**Free up drainage.**

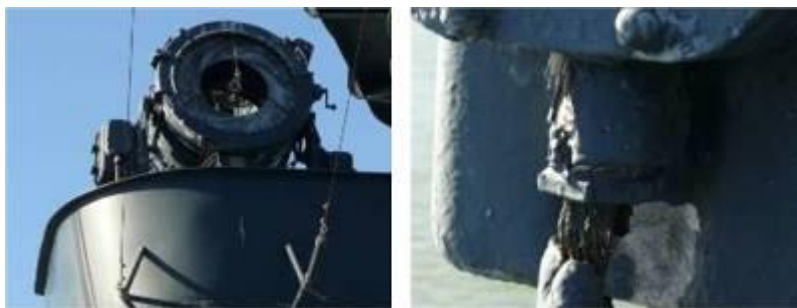
**Figure 39 Starboard Searchlight (Left) and Detail of Degradation of Searchlight (Right)**

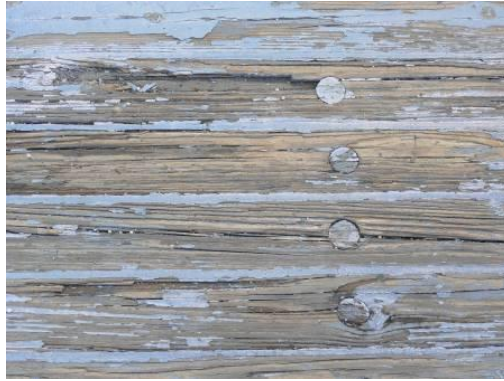
The exterior deck (Figure 42) is sheathed with what appears to be yellow pine (3 in. x various width) decking in need of repair due to ingress of water through the paid seams or through the various margin plates or gun mounts. The usual issues of drainage, wooden deck maintenance and cosmetics are the main concerns.

**Figure 42 Wood Decking on Superstructure Deck**

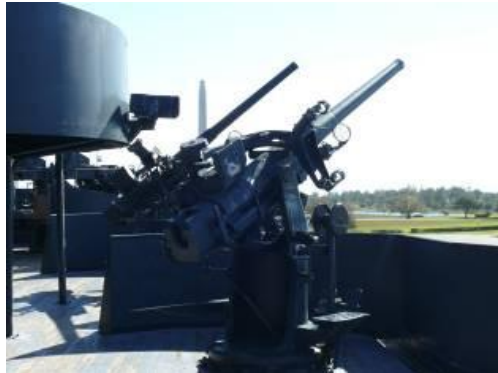
The 40 MM gun mounts (Figure 43, Figure 44 and Figure 45) are suffering from lack of maintenance and are corroding freely.

**Figure 43 Superstructure Deck (Looking Forward to Starboard)**

**Repair, prep, prime and paint 40MM gun mounts**

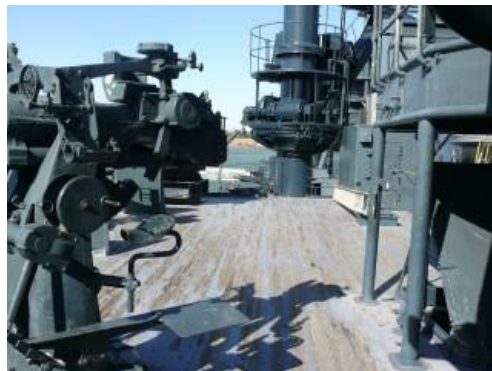
**Figure 44 Superstructure Deck (Looking Aft to Starboard)**

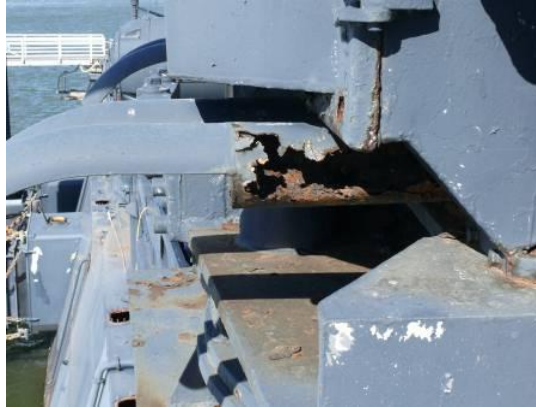
**Figure 45 Sample of Rust/Scale Causing Widespread Degradation on the 40 MM Mounts**

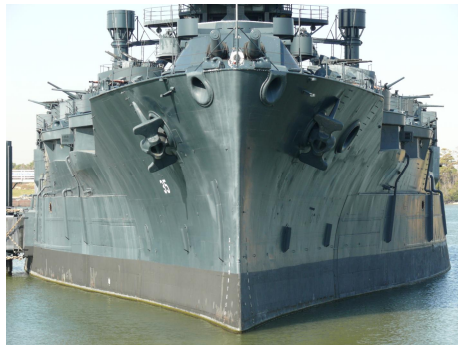
The deck towing eyes and their foundations, forward and aft, are in good structural condition. The starboard anchor is not properly housed (see Figure 46) in that the anchor has not been pulled into her stops in the hawse pipe.

**Figure 46 Starboard Anchor Not Properly Housed**

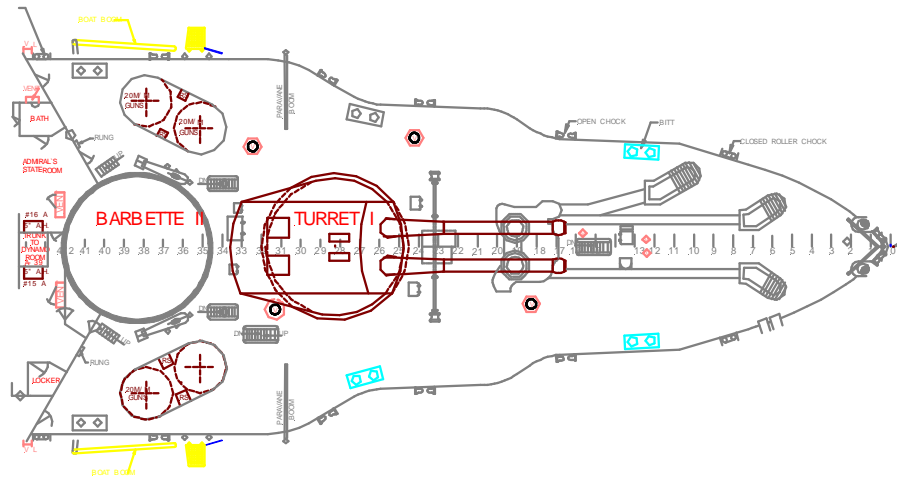
**Figure 47 Main Deck (Stem to Turret No.2) Layout**

The main deck (Figure 47 and Figure 48) is the main public access area and is central to the mission of displaying the ship. This area of main deck contains the anchor gear/chain, pelican hooks, steam anchor windlass wildcats/warping capstans, and Turrets No. 1 & No. 2. The main deck has a wooden deck installed. Handrail stanchions with double lifelines are fitted around the perimeter of the deck. The forward towing eyes are installed on the centerline forward. Chocks and double bitts are fitted for securing the vessel. The usual problems of rust/scale and water under the wooden deck are found here.

**Repair the wooden deck on an 'as needed' basis.**

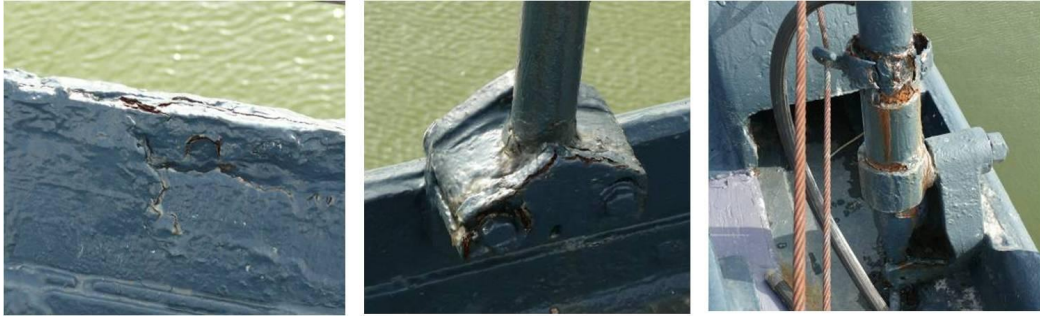
Structurally, the main deck and its support scantlings are in good repair in this area and there is no cause for concern. The outer splash shields forward are heavily corroded between overlapping plates of steel (Figure 49).

**Figure 49 Heavy Rust/Scale at Overlapping Plating (Left), Corroded Base of Handrail Stanchion on Main Deck Forward to Starboard (Middle), Wasted Handrail Stanchion on Main Deck Forward to Starboard (Right)**

**Repair/replace the steel lifeline stanchions requiring new bases. Consider netting to be fitted as a safety precaution on the lifelines.**

**Repair the wasted lifeline loose strands emanating from the lifeline around the perimeter of the forward main deck**

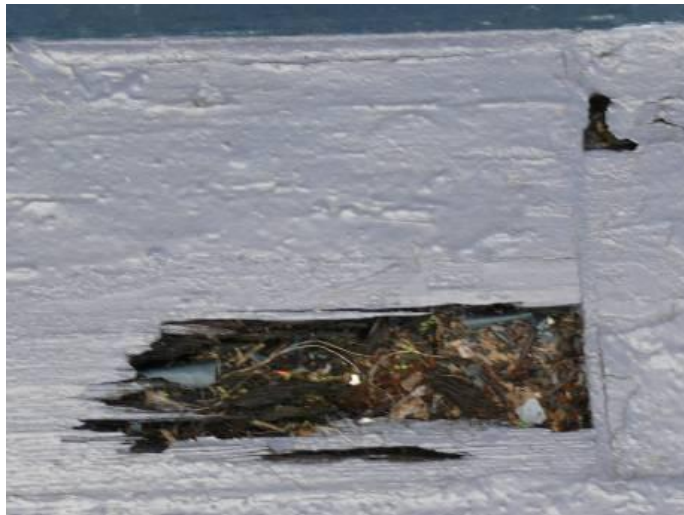
This area of the main deck appears to be in good structural condition being heavily constructed. The effects of poor drainage are apparent in the athwartships passageway where water has started to corrode the overhead scantlings and plating. The gun mounts rest on the wooden decking and corrosion/rot are apparent (Figure 52, Figure 53 and Figure 54).

**Figure 52 Wasted Wooden Decking on Main Deck (Trip/Fall Hazard)**

**Repair/replace wood decking and structural foundations of mounts as needed, repair/replace wasted steel decking and install new steel deck as needed.**

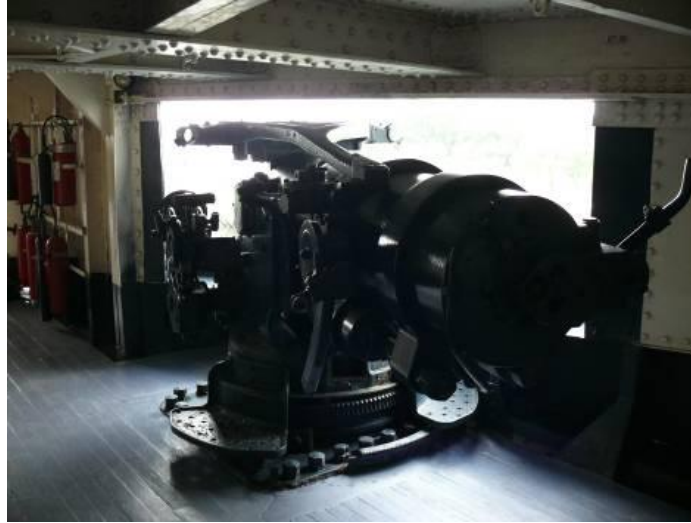
**Figure 53 5 in. Gun Under Armored Enclosure (Wasted Wooden Decking Beneath Foundation and Steel Decking Impacted Within the Area Adjacent to Mounts)**

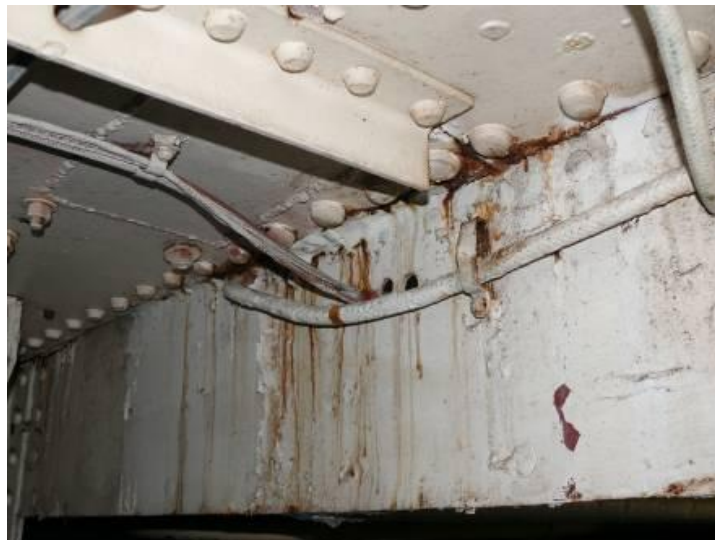
**Figure 54 Rust/Scale and Deterioration of Scantlings on Overhead in Athwartships Passageway**

**Creative methodologies for shedding/drainage water is key to avoid all consuming rust/scale issues.**

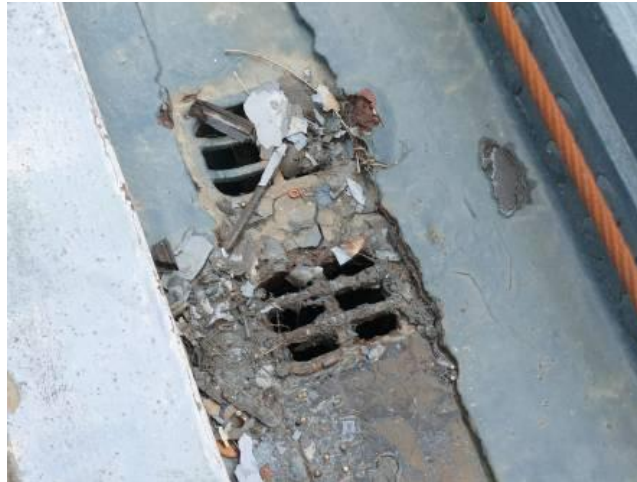
Ventilator, gun tub and davit bases are impacted by standing water adjacent to the wooden decking causing serious degradation with the passage of time. Main deck hatches are also facing the same issues with wasted frames where they are fitted flush to the wooden decking (Figure 55 and Figure 56).

**Figure 55 Standing Debris Over Deck Drain on Margin Plate to Starboard**

**Removal and repair/replacement of wasted bases at the bases of ventilators cowling, gun tubs and davit bases is badly needed.**

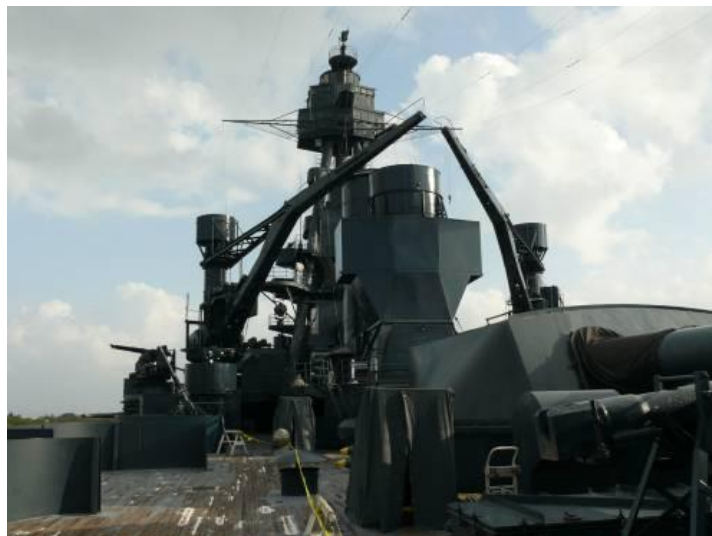
**Figure 56 Main Deck (Looking Forward to Port; Wooden Decking Being Replaced by Vessel's Maintenance Crew)**

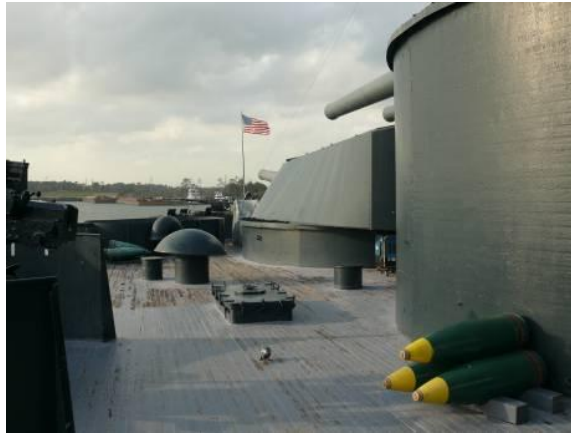
This area of the main deck (Figure 58 and Figure 59) appears to be in good structural condition being heavily constructed. The gun mounts rest on the wooden decking and corrosion/rot are apparent. The gun mounts themselves have experienced the effects of rust/scale due to delaminated painting system.

**Figure 58 Fantail (Looking Aft to Starboard)**

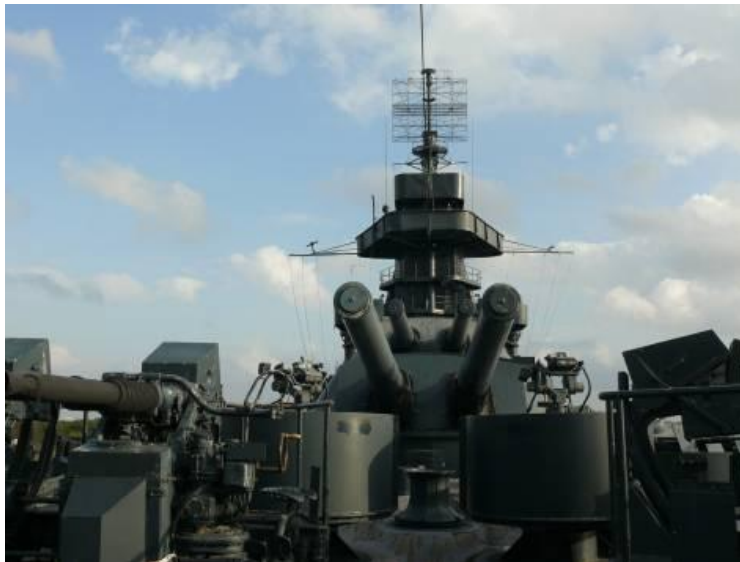
**Figure 59 Fantail on Main Deck (Looking Forward)**

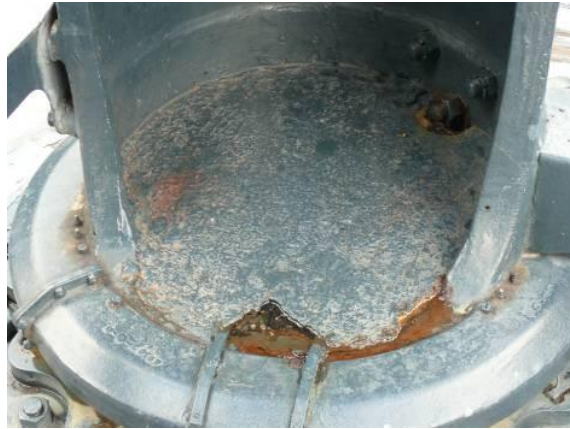
Issues of drainage continue to cause recurring damage to paint system, handrail stanchions and deck structure (Figure 60, Figure 61, Figure 62 and Figure 63). The stanchions for handrails are badly affected in some areas. The handrail lifelines have wire burrs. The side deck margins have rust/scale from dirt/standing water and is an endemic problem. The ventilator, gun tub and davit bases are impacted by standing water adjacent to the wooden decking causing serious degradation with the passage of time. Removal and replacement of wasted bases and cowlings at the bases of these components is ongoing and is badly needed. Main deck hatches are also facing the same issues with wasted frames where they are fitted flush to the wooden decking.

**Figure 60 Concrete Poured Into Base of 3 in. Gun Causing Heavy Rust/Scale to Mount and Underlying Main Deck**

**Remove concrete from gun tubs, repair/replace decking and structural foundations of mounts as needed and re-install new steel deck as needed.**

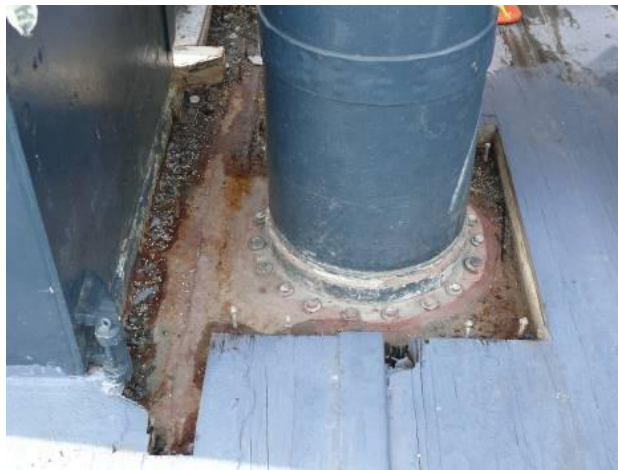
**Figure 61 Deck Repair Underway (Forward of Main Mast)**

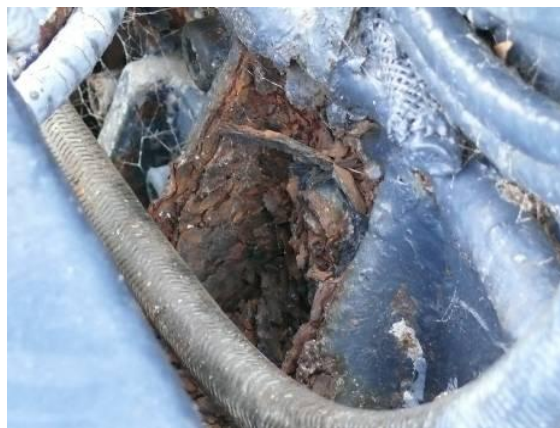
**Figure 62 Debris and Rust/Scale on Main Deck (Aft)**

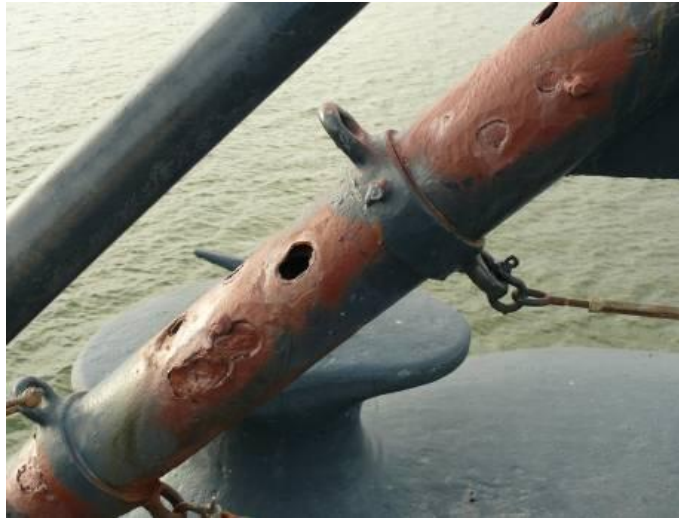
**Figure 63 Stern Flag Pole Brace Severely Holed from Corrosion**

**Some stanchions and bases require immediate repair.**

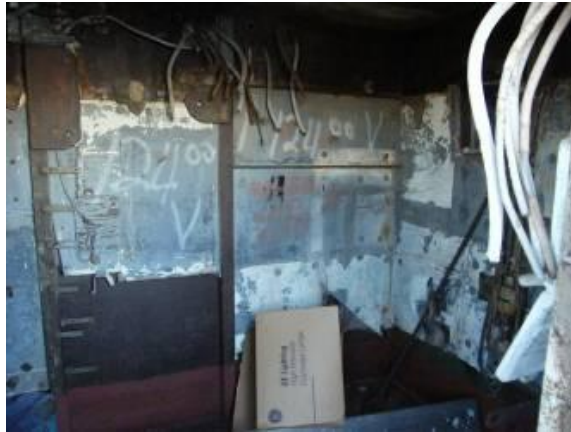
**Figure 71 Radio Room**

This structure (Figure 71) is in rough cosmetic condition with stripped out wiring harness, equipment and furniture missing. The space needs restoration.

<b>Prepare, prime and paint space as needed.</b>
--

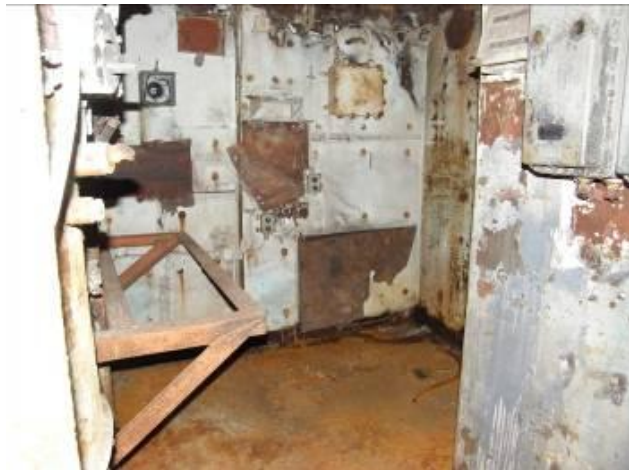
**Figure 72 Flag Bridge Interior**

This space (Figure 72) is in rough cosmetic condition with stripped out wiring harness, equipment and furniture missing. The space needs restoration. Standing water (Figure 73) is present in this space.

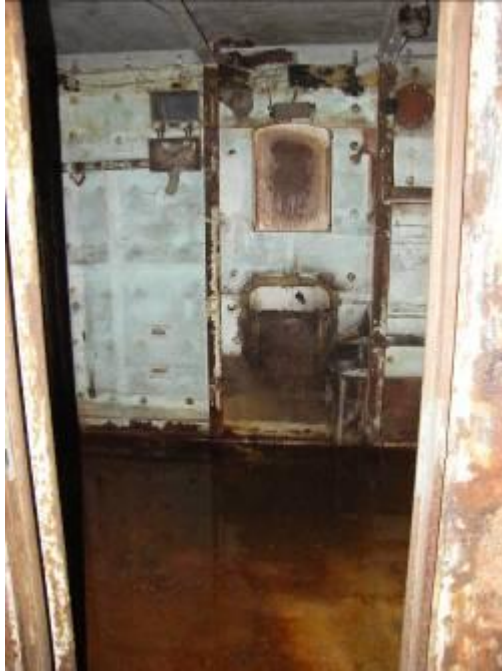
**Figure 73 Standing Water Within Flag Bridge**

**Cure intruding water ingress from overhead**

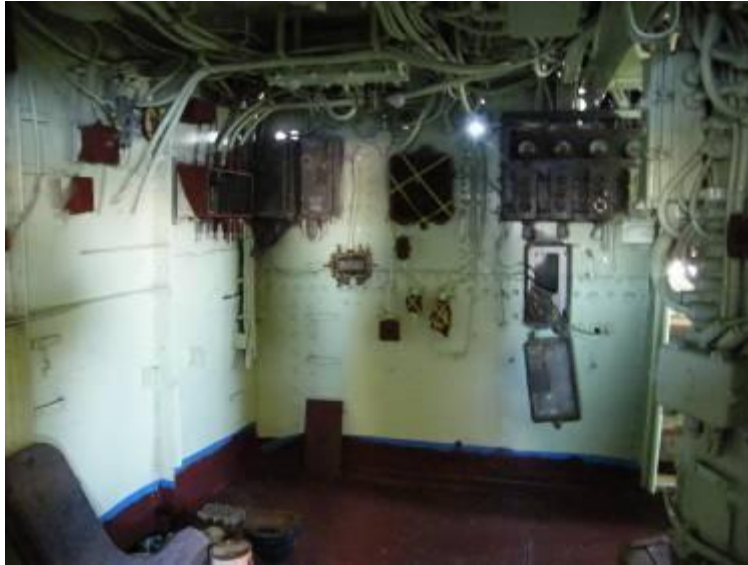
**Figure 75 Bridge Radio Room**

This space (Figure 75) is in great cosmetic condition, but there is holed vertical plating on the aft bulkhead at deck.

<b>Repair aft vertical holed bulkhead as needed.</b>
--

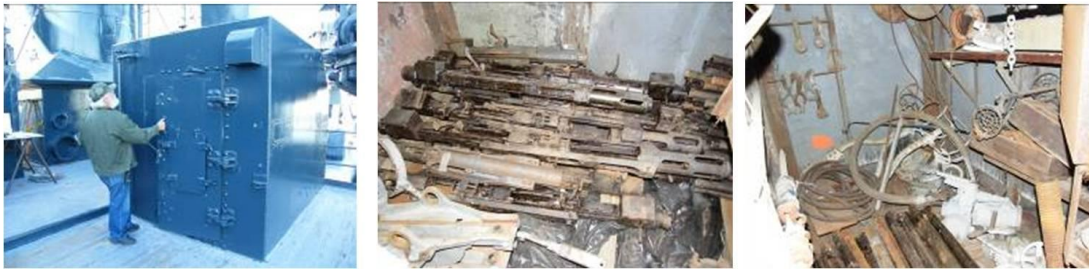
**Figure 82 Storage Lockers on Superstructure Deck**

This space (Figure 82) is largely in fair cosmetic and good structural condition and the spaces are utilized for lifejackets, 20 MM barrels & 40 MM barrel storage.

<p><b>Prepare, prime and paint space as needed.</b></p>
---

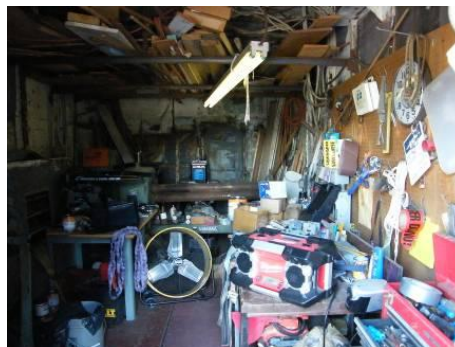
**Figure 83 Carpenter Shop**

This space (Figure 83) is largely in fair cosmetic and good structural condition and spaces are utilized for light tools, personal gear and spare lumber stock/ storage.

<p><b>Prepare, prime and paint space as needed.</b></p>
---

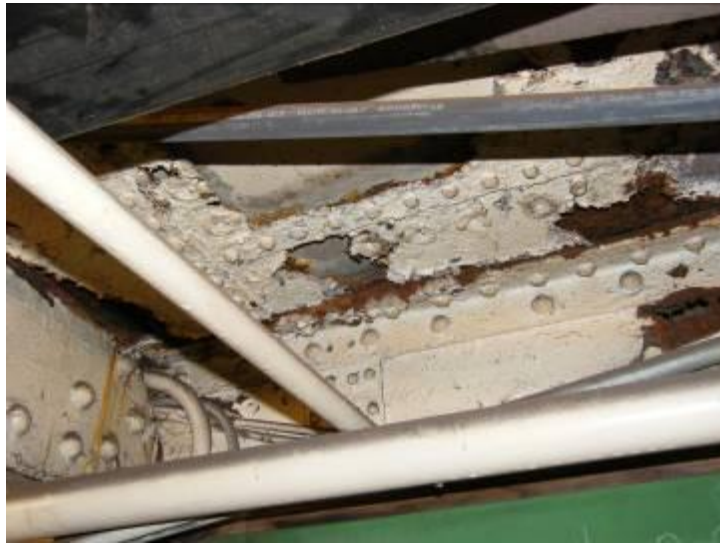
An athwartships space, this space (Figure 89) contains all manner of tools, work benches, power equipment and storage for the Maintenance Crew's gear. This space is in fair/good cosmetic and structural condition. The overhead under the air defense tower is rusted/scaled through and is in need of repair (Figure 90).

**Figure 90 Waster Overhead in Shipfitter Shop**

**Repair overhead as needed with new steel.**

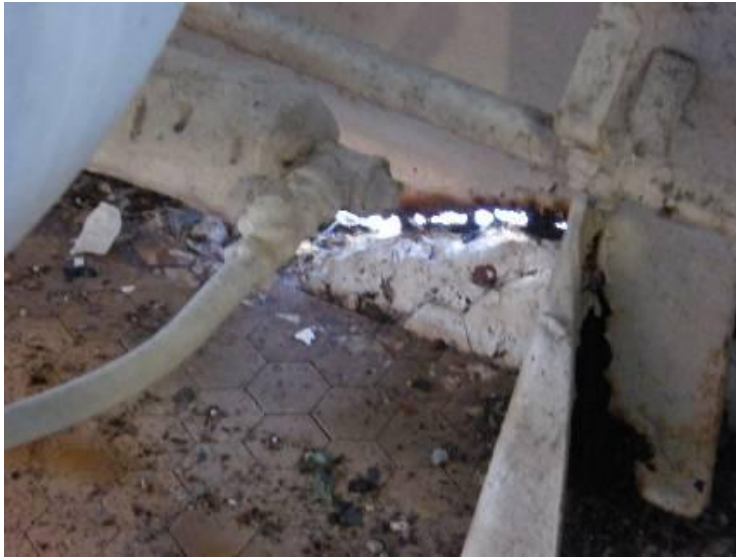
Also, vertical sides at the bases of bulkheads are rotting away and have failed in many areas of the galley (Figure 92; see also Figure 93).

**Figure 92 Wasted Vertical Steel at Bulkhead in Crew Galley**

**Repair/replace waster/scaled steel bulkheads and floors as needed.**

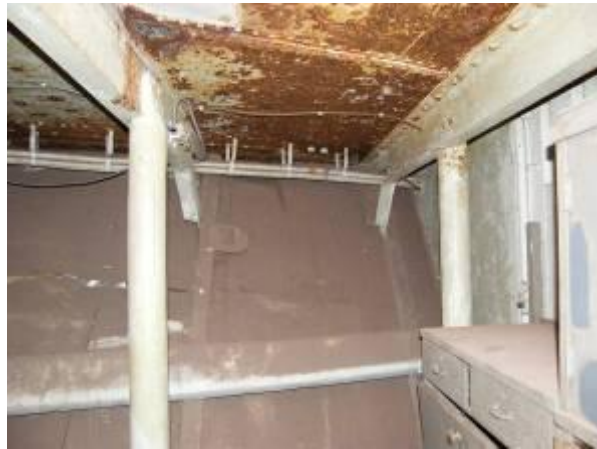
**Figure 96 Stateroom "M"**

This space (Figure 96) is in good structural and poor cosmetic condition.

<b>Prepare, prime and paint space.</b>
--

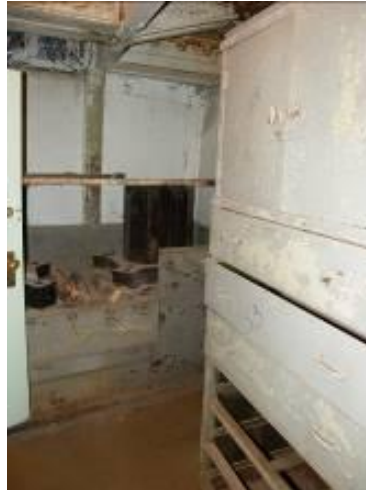
**Figure 97 Stateroom "L"**

This space (Figure 97) is in good structural and poor cosmetic condition.

<b>Prepare, prime and paint space.</b>
--

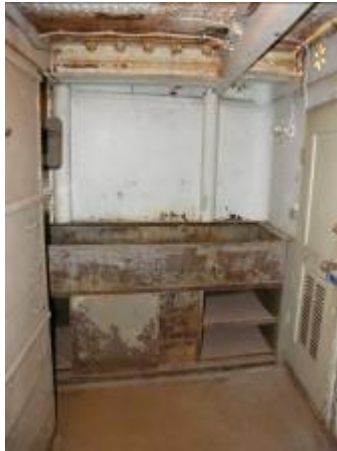
**Figure 98 Stateroom “K”**

This space (Figure 98) is in good structural and poor cosmetic condition.

<b>Prepare, prime and paint space.</b>
--

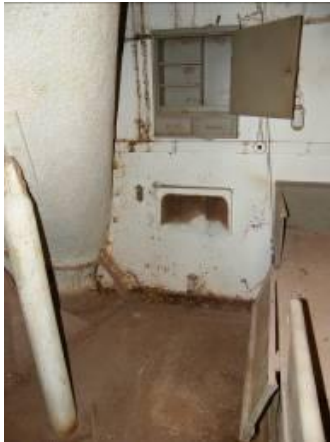
**Figure 99 Stateroom “BB”**

This space (Figure 99) is in good structural and poor cosmetic condition. There were minor leaks from overhead.

<b>Seal deck leaks on overhead. Prepare, prime and paint space.</b>
---

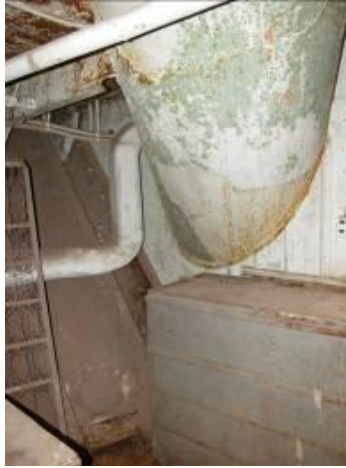
**Figure 100 Stateroom "Z"**

This space (Figure 100) is in good structural and poor cosmetic condition. There were minor leaks from overhead.

<b>Seal deck leaks on overhead. Prepare, prime and paint space.</b>
---

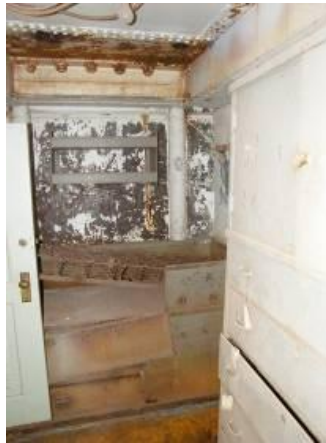
**Figure 101 Stateroom "Y"**

This space (Figure 101) is in good structural and poor cosmetic condition. There were minor leaks from overhead.

<b>Seal deck leaks on overhead. Prepare, prime and paint space.</b>
---

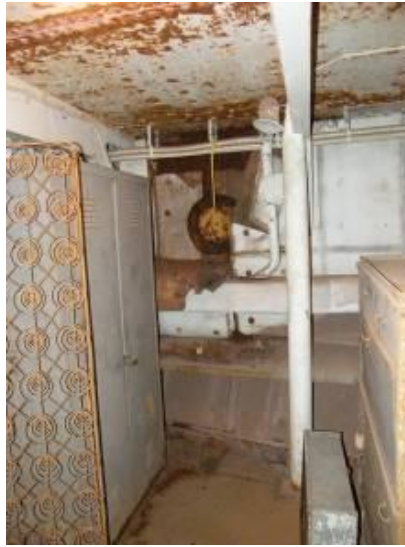
**Figure 102 Stateroom "X"**

This space (Figure 102) is in good structural and poor cosmetic condition. There were minor leaks from overhead.

<b>Seal deck leaks on overhead. Prepare, prime and paint space.</b>
---

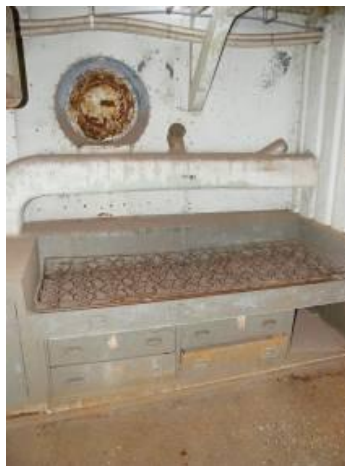
**Figure 103 Stateroom "W"**

This space (Figure 103) is in good structural and poor cosmetic condition.

<b>Prepare, prime and paint space.</b>
--

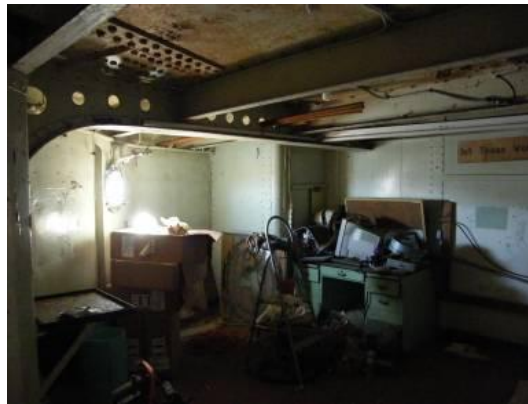
**Figure 107 Stateroom "H" (Starboard)**

This space (Figure 107) is in good structural and poor cosmetic condition, and there is much debris and loose gear in this space.

<b>Prepare, prime and paint space.</b>
--

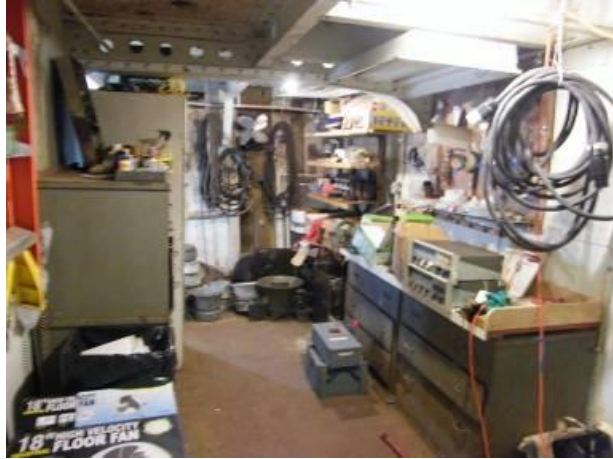
**Figure 108 Stateroom G-2 (Starboard)**

Utilized as a work shop and storage for spares, tools, etc. this space (Figure 108) is in good structural and good cosmetic condition.

<p><b>Prepare, prime and paint space.</b></p>
---

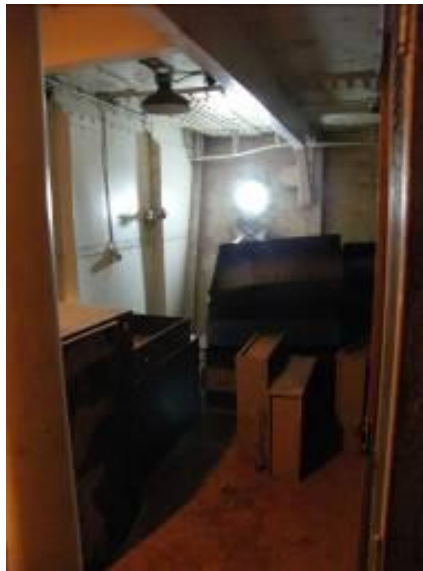
**Figure 109 Stateroom "G" (Starboard)**

This space (Figure 109) is in good structural and poor cosmetic condition with heavy rust/scale present throughout the space.

<p><b>Prepare, prime and paint space.</b></p>
---

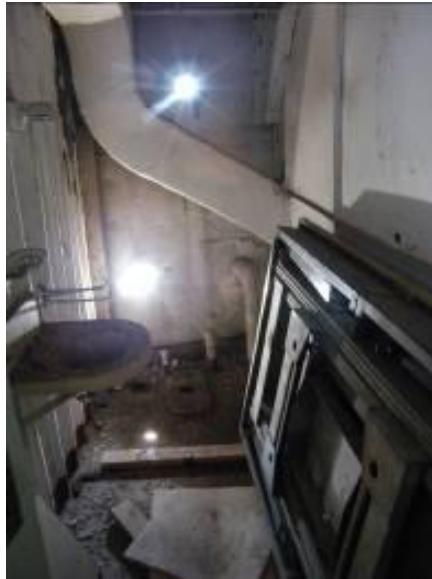
**Figure 110 Head W.C (Starboard)**

This space (Figure 110) is in good structural and poor cosmetic condition. There is heavy rust/scale present throughout the space with holed exterior plating.

**Repair holed exterior shell plating, remove debris in space.**

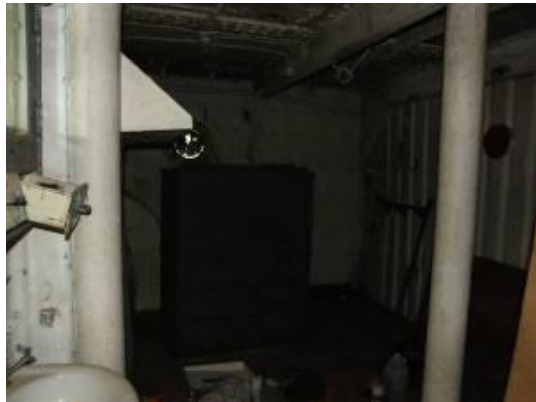
**Figure 111 Stateroom "E" (Starboard)**

This space (Figure 111) is in good structural and poor cosmetic condition.

**Prepare, prime and paint space.**

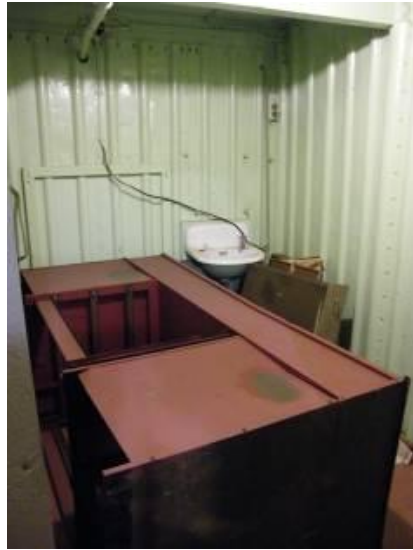
**Figure 112 Stateroom “D” (Starboard)**

This space (Figure 112) is in good structural and good cosmetic condition.

**Prepare, prime and paint space.**

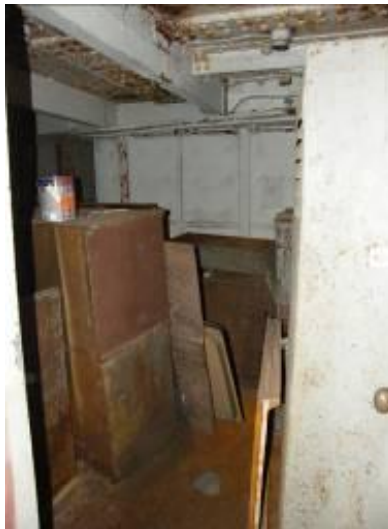
**Figure 113 Stateroom “C” (Starboard)**

This space (Figure 113) is in good structural and fair cosmetic condition. There is rust/scale and debris throughout the space.

**Prepare, prime and paint space.**

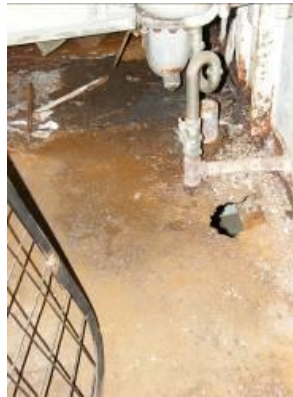
**Figure 114 Stateroom "B" (Starboard)**

This space is in poor structural and cosmetic condition. There is rust/scale and debris throughout the space as well as wasted away deck that needs replacement.

**Repair wasted deck as this is a safety issue.**

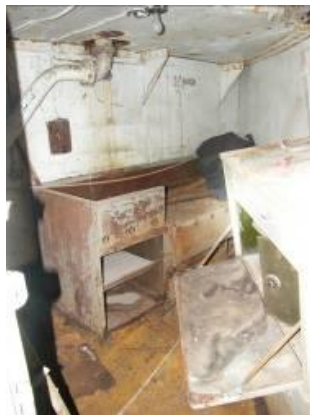
**Figure 115 Stateroom "A" (Starboard)**

This space is in poor structural and cosmetic condition with rust/scale and debris throughout the space. The deck is wasted away and needs replacement.

**Repair wasted deck as this is a safety issue.**

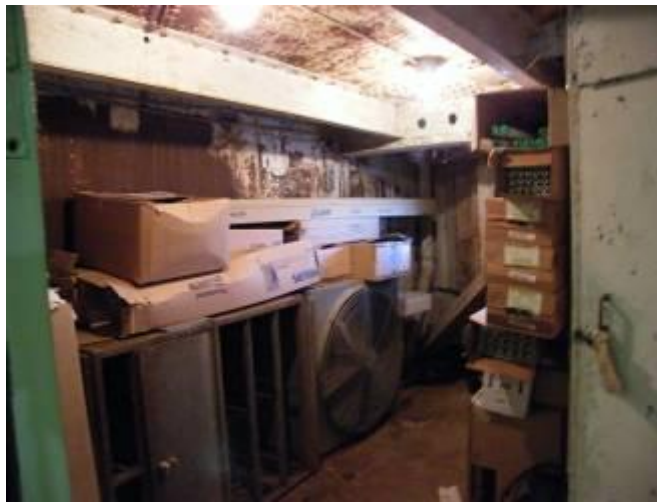
**Figure 117 Stateroom U-4 (Port)**

Utilized as a storeroom, there is much rust/scale throughout this space (Figure 117).

<p><b>Prepare, prime and paint space.</b></p>
---

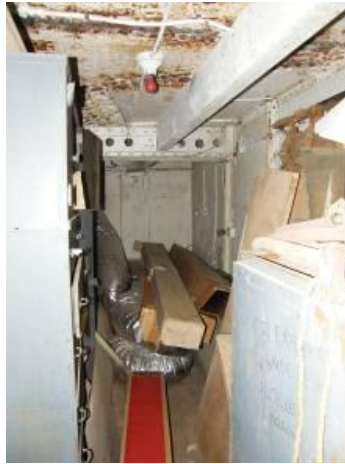
**Figure 118 Stateroom "U-3" (Port)**

Utilized as a storeroom, there is much rust/scale throughout this space (Figure 118).

**Prepare, prime and paint space.**

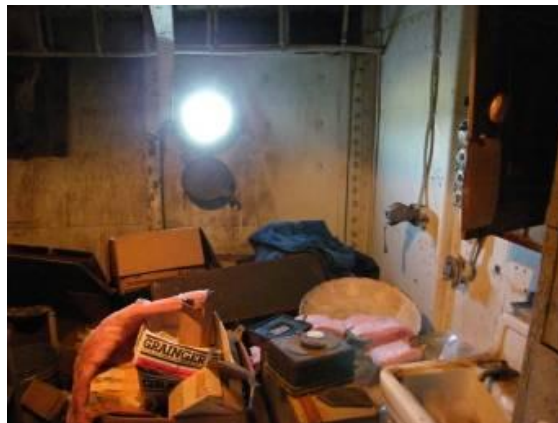
**Figure 119 Stateroom "U-2" (port)**

This space (Figure 119) is in good structural and poor cosmetic condition. Utilized as a storeroom, there is much rust/scale throughout this space.

**Prepare, prime and paint space.**

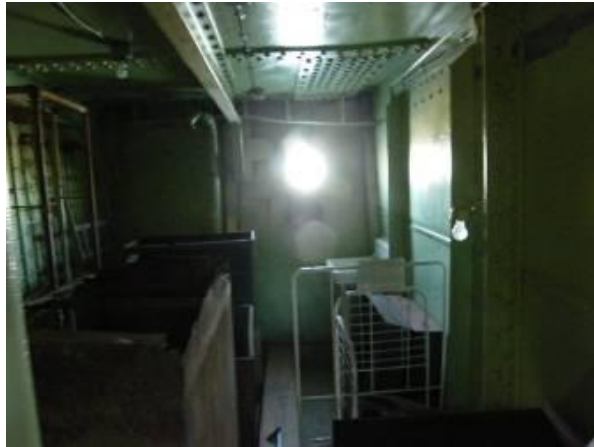
**Figure 120 Stateroom “U-1” (Port)**

This space (Figure 120) is in good structural and poor cosmetic condition.

<b>Prepare, prime and paint space.</b>
--

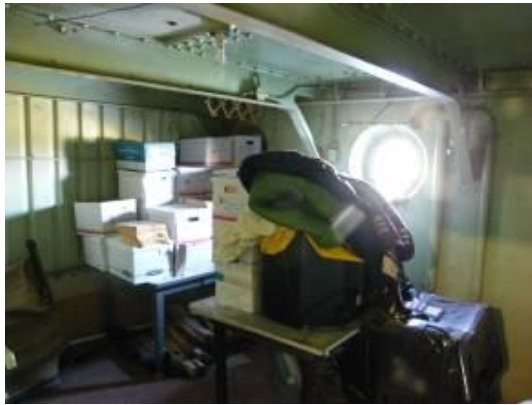
**Figure 121 Stateroom “T” (Port)**

This space (Figure 121), utilized as a store room, is in good structural and cosmetic condition.

<b>Prepare, prime and paint space.</b>
--
